## Learning from Earthquakes

# The $M_w$ 8.8 Chile Earthquake of February 27, 2010

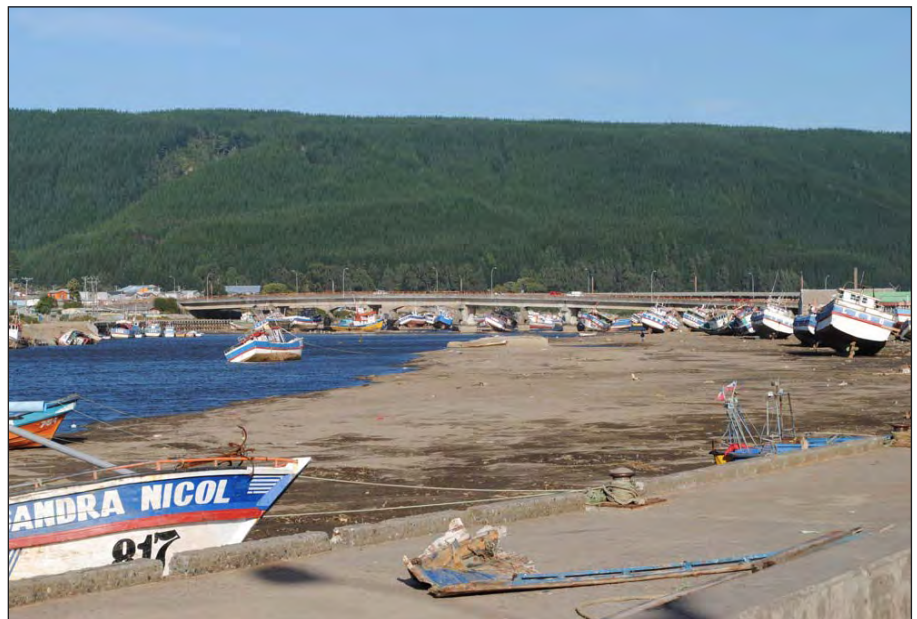
uplift affected harbor facilities (Figure 3), produced an emergent marine platform, and exposed the tidal habitat zone. In the central part of the rupture zone, coastal subsidence over a distance of about 50 km between the towns of Constitución and Bucalemu

**Figure 3.** Fishing boats stranded within uplifted harbor of Lebu; uplift of 1.8 +/- 0.2 m in this area (photo: GEER, 2010).

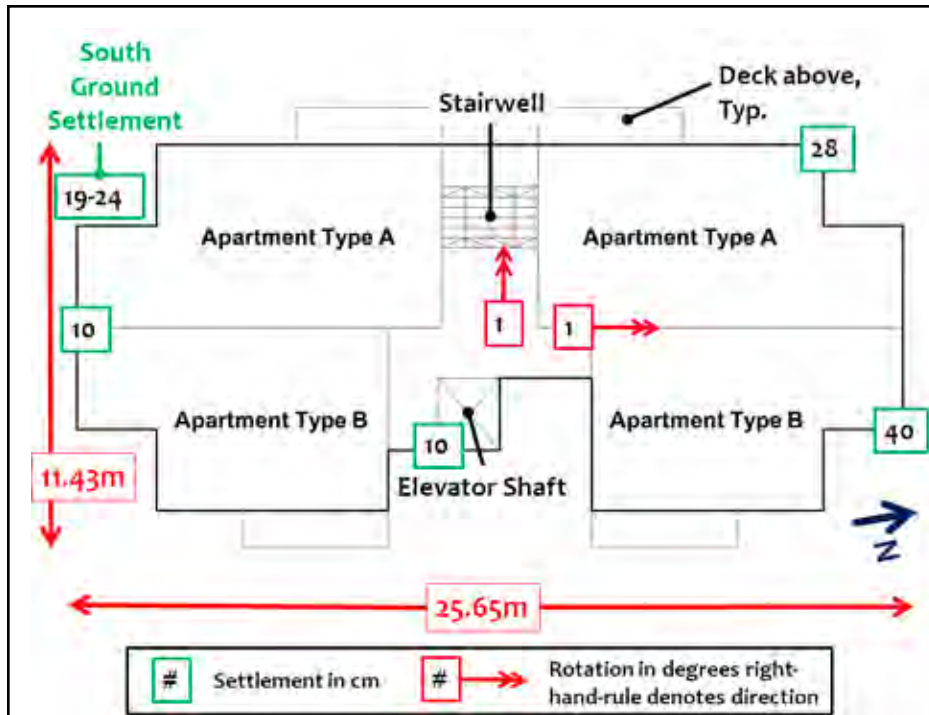
**Figure 5.** Schematic plan view of the Riesco building in Concepción (GEER, 2010).

ferential settlement across its foundation and 1 degree tilt in the north side of the building (Figure 5). As a result of the uneven foundation settlement and rotation, excessive internal deformations were imposed on the coupling beams in the superstructure. Several homes in northern Concepción were torn apart by translational ground movement.

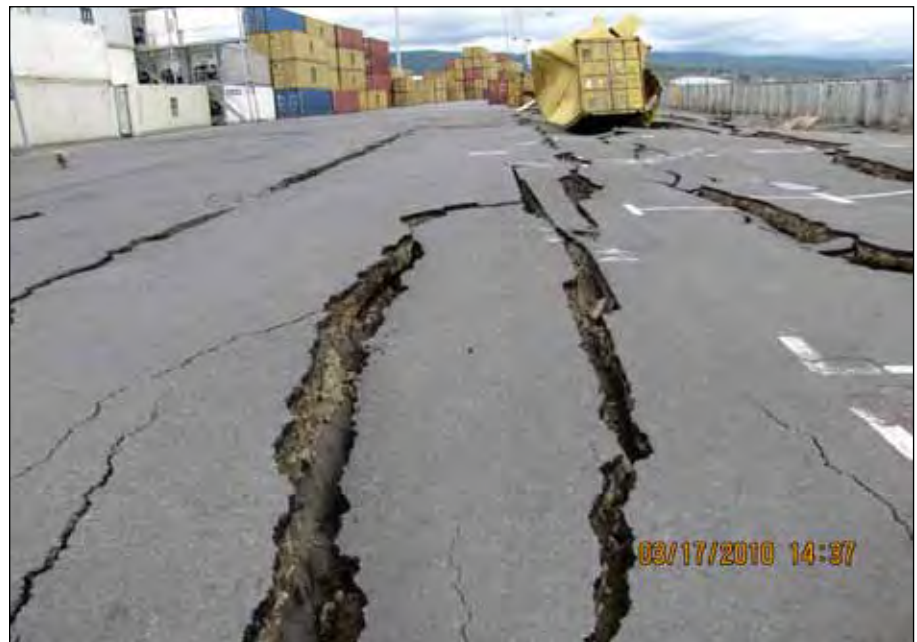
**Ports.** Ports are essential facilities for the Chilean economy, as they carry more than 90% of the country's imports and exports. There was significant damage due to liquefaction and lateral spreading, notably at Valparaíso and Coronel. Figure 6 shows cracking of asphalt pavement at Coronel with lateral ground extension in excess of 1.2 m.

**Figure 6.** Liquefaction and lateral spreading-induced damage at the Port of Coronel (photo: GEER, 2010).

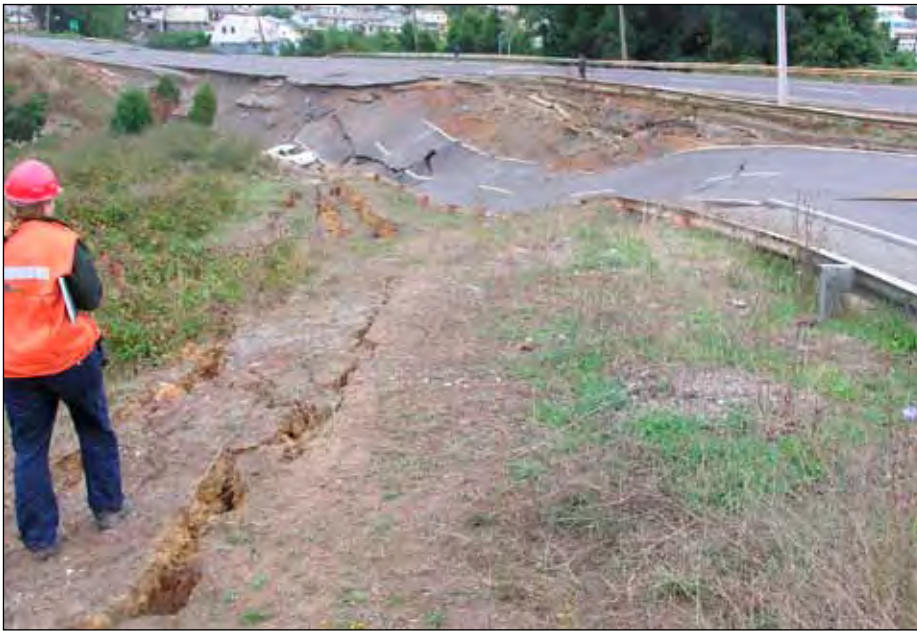
Localized ground failures also had widespread impact on highways throughout the region affected by the earthquake. Route 160 in Lota along the coast was closed in both directions due to embankment slope failures (Figure 7). Several ground failures were observed inland along the main north-south highway, Route 5, often resulting in the closure of either northbound or southbound lanes (e.g., near Copihue, Parral,

**Figure 7.** Slope failure on Route 160 in Lota (photo: GEER 2010).

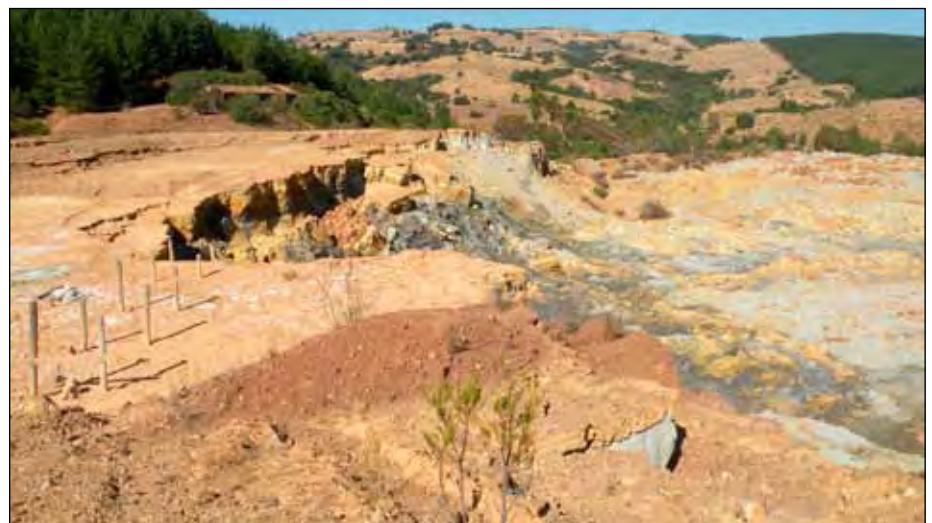
**Earthen Structures.** The performance of earthen structures — dams, levees, mine tailings dams, and retaining structures — was good overall. The earthquake struck near the end of the dry season in Chile, when reservoir levels are low. A small number of earth structures did exhibit adverse effects. For example, Coihueco Dam, which is a 31-m-high zoned earth fill dam, had several scarps along its upstream crest, as well as bulging along the upstream toe. The most significant failure of an earth structure was at the Las Palmas Tailings Impoundment, where liquefaction resulted in a flow failure of as much as 100,000 m<sup>3</sup> of retained tailings a distance of up to 0.5 km and caused four casualties (Figure 8). Another interesting failure was in a 7-m-high earth levee constructed with a silty-sandy gravel with cobbles near Colbún. While this section of levee showed no signs of distress after both the February 27 event and a  $M_w$  6.9 aftershock on March 11, it subsequently failed on March 13.

**Figure 8.** Upper scarp of Failed Tailings Impoundment (photo: GEER 2010).

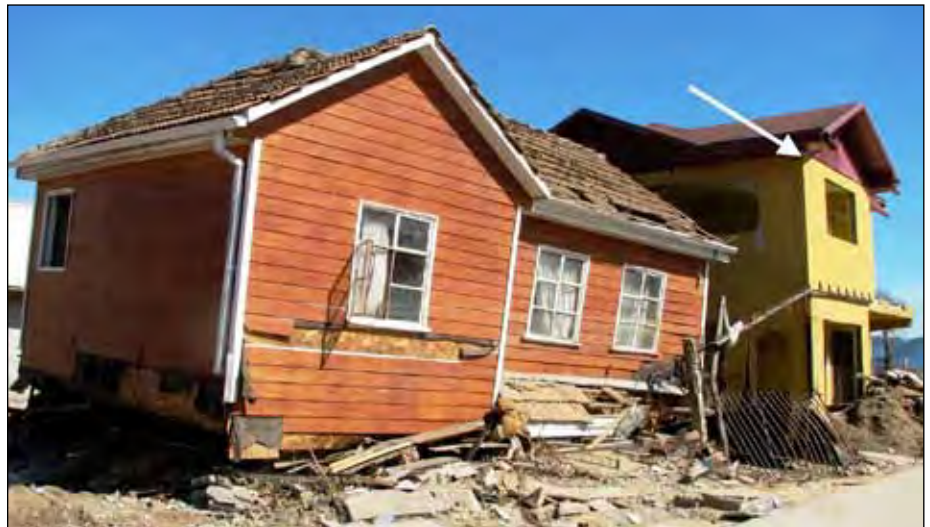
Tsunami damage to structures resulted from hydrodynamic loading on structural elements, impact loading from floating debris, and scour around foundations, especially during drawdown. Timber-framed homes and unreinforced or poorly reinforced masonry structures were particularly vulnerable (Figure 9). In Dichato, 1500 homes were

destroyed, primarily because of hydrodynamic loads, though debris generated by failed homes may have progressively contributed to the loading. Light-framed buildings were destroyed in many other coastal towns. Reinforced concrete buildings, on the other hand, performed very well structurally, even when inundation reached well above the second floor level.

**Figure 9.** Wood building on left in Dichato was transported from across street and collided with the concrete frame building on the right. Arrow shows water height (photo: L. Dengler).

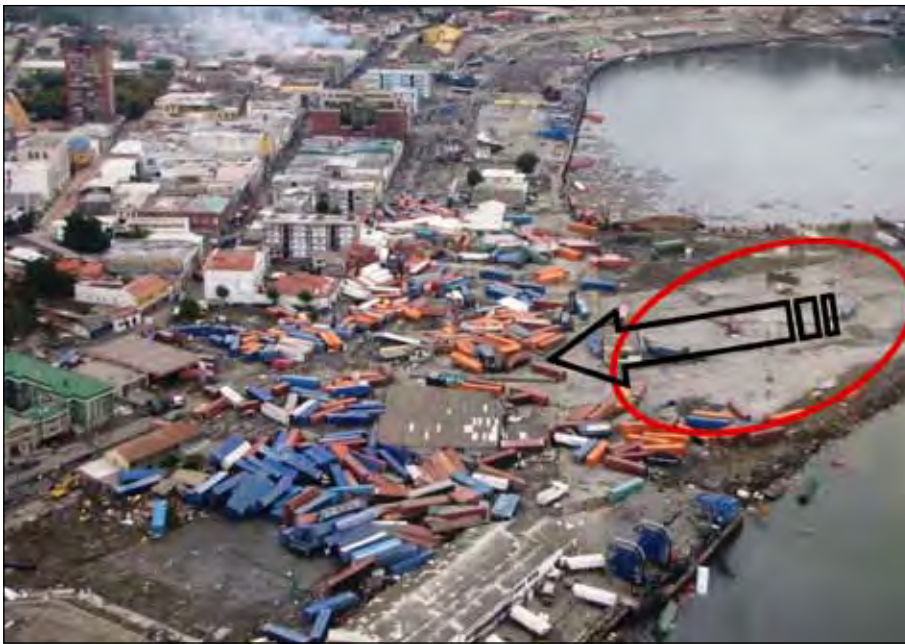
In Talcahuano, nonstructural damage was widespread; almost all exterior enclosures and contents of commercial buildings and industrial warehouses along the shorefront were damaged by the hydrodynamic loading of the flooding and debris field, and the commercial fishing facilities along the wharf were also rendered inoperable. Debris impact, particularly in the form of fishing vessels, shipping containers, and trucks, caused damage to masonry and steel-framed harbor buildings, though reinforced concrete structures were generally able to withstand the battering (Figure 10). The piers at the Naval Base at Talcahua-

**Figure 10.** Talcahuano Harbor 3 days after the tsunami (photo: Intl. Federation of Red Cross Red Crescent Societies). Shipping containers were originally stacked in the area of the red ellipse and displaced up to 300 m in the direction of the arrow.

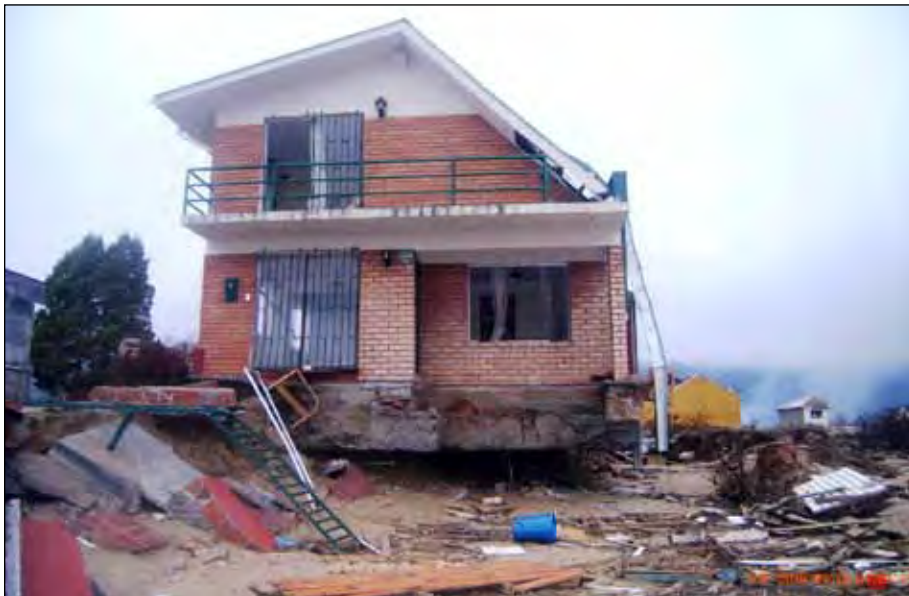
Scouring of shallow foundations caused a number of buildings to collapse (Figure 11). Sheetpile wharfs in Talcahuano Harbor collapsed or were damaged by soil failure induced by tsunami inundation and drawdown. Elevated pore pressures led to fluidization of backfill during tsunami inundation and drawdown, causing severe scour that damaged sheetpile wharf structures, machinery with shallow foundations, and soil-supported pavements. Eyewitness reports from dockworkers indicated that the majority of damage was caused by the tsunami. According to Ministry of Interior data in May 2010, 124 of the 521 identified

**Figure 11.** This concrete frame and confined masonry building in Dichato survived the hydrodynamic loads, but suffered substantial foundation scour (photo: G. Chock).

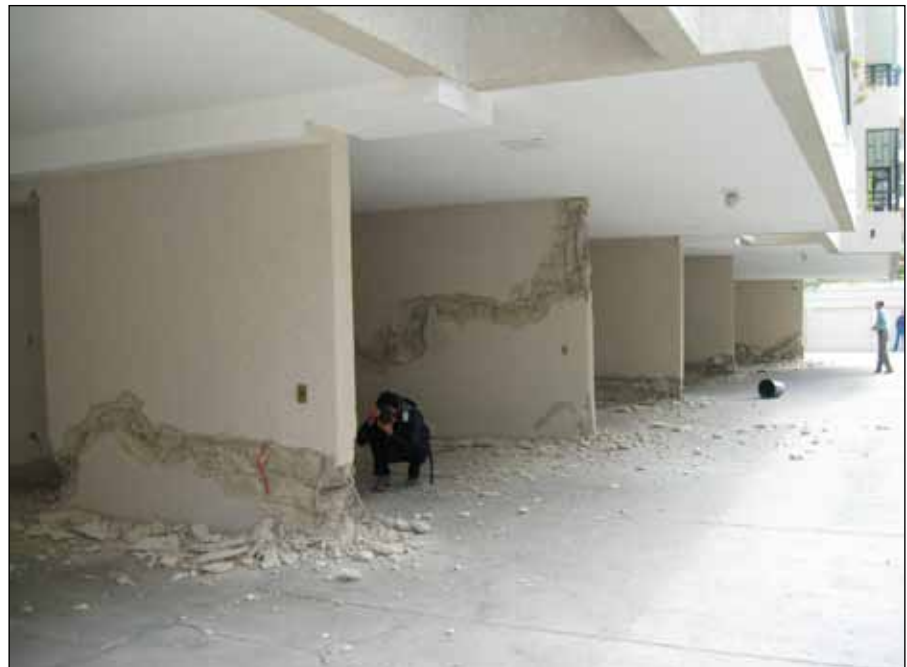
Figure 15 shows typical damage to a transverse wall in the first story of a ten-story building in Viña del Mar. Note the setback in the wall profile at this level, provided mainly to accommodate automobile access to parking spaces. This condition was observed in several buildings; in buildings with subterranean parking, this damage was likely in the first level below grade.

**Figure 15.** Wall damage, Viña del Mar (photo: P. Bonelli).

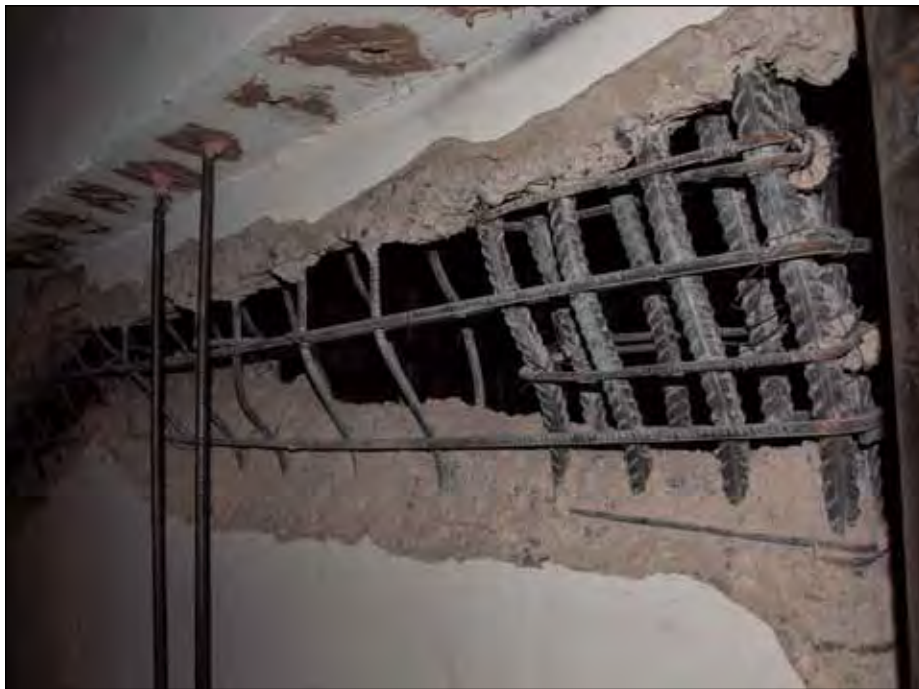
Figure 16 shows a failed wall from a subterranean level of a 12-story building in which large steel pipe columns were being used to raise the building to enable repairs. Given the wide spacing of transverse reinforcement, there was little bearing section remaining in the thin wall and the entire wall section buckled laterally. In this example the longitudinal bars buckled without fracture; in many other examples the longitudinal bars were fractured. It was reported that, even though not required by the local building code, some engineers used transverse reinforcement conforming to the ACI Building Code. The team did not observe that type of reinforcement in any damaged buildings.

**Figure 16.** Wall damage, Santiago. Note the 90-degree bends on the transverse reinforcement (photo: J. Wallace).

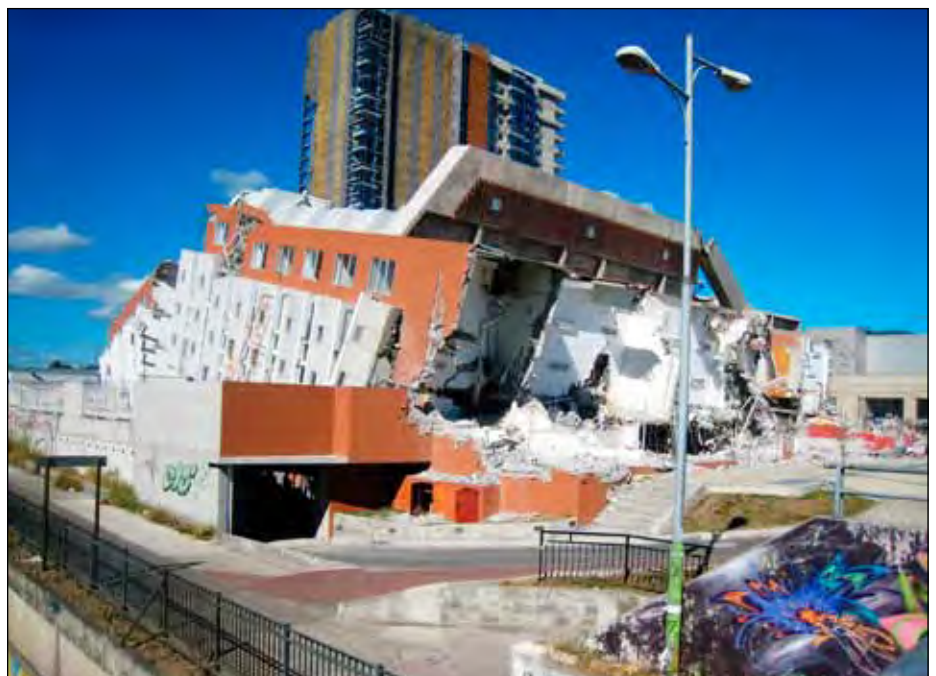
A third collapsed building was the 15-story Alto Río condominium in Concepción (Figure 17). The team was unable to examine closely the side of the building toward which it collapsed, but the structural drawings indicate that concrete walls on the façade were discontinued, and the wall length was decreased in the first story on the side toward which the building collapsed. The building apparently rotated about its corridor walls as it collapsed, leading to tension failures of the transverse walls on the other side (the side from which the photo was taken). Some of the wall vertical reinforcement fractured and some lap splices failed on the tension side.

**Figure 17.** Collapsed Alto Río tower showing underside (photo: J. Maffei).

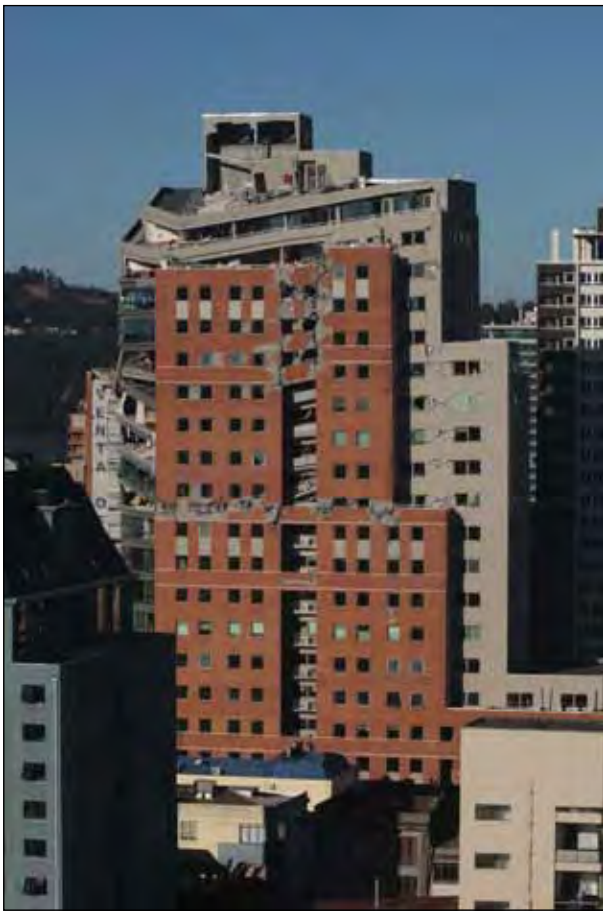
The recently completed 23-story O'Higgins 241 office tower in Concepción suffered partial story collapses at levels 10, 14, and 18, each coincident with a framing setback (Figure 18). The perforated shear walls on the east face (shown) and south face showed damage to both wall piers and spandrels. Exterior north and west faces appeared undamaged.

**Figure 18.** O'Higgins 241 office tower (photo: E. Miranda).

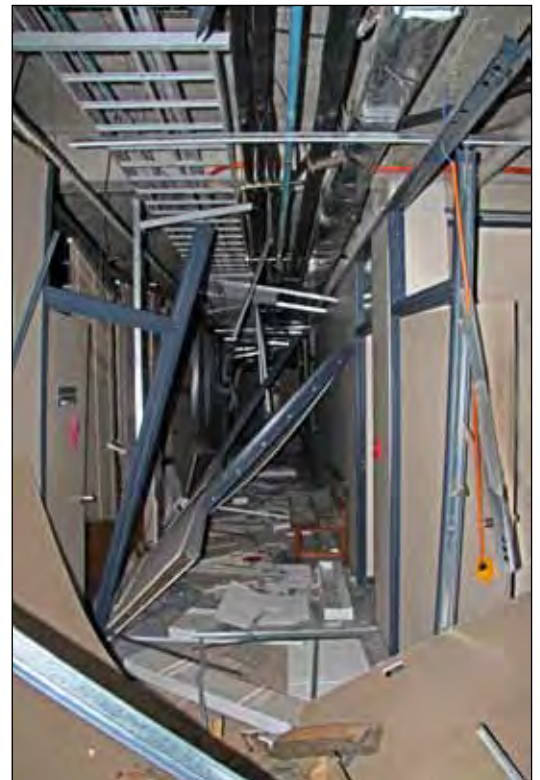
damage in practically all types of buildings — residential, commercial, and industrial. Commonly observed was damage to glazing, ceilings, fire sprinkler systems, piping systems, elevators, partitions, air handling units,

and cable trays (Figure 19). The widespread nonstructural damage caused significant economic loss and major disruption to the normal functioning of Chilean society.

**Figure 19.** Nonstructural damage in the Talca Supreme Court building constructed in 2003 (photo: E. Miranda).

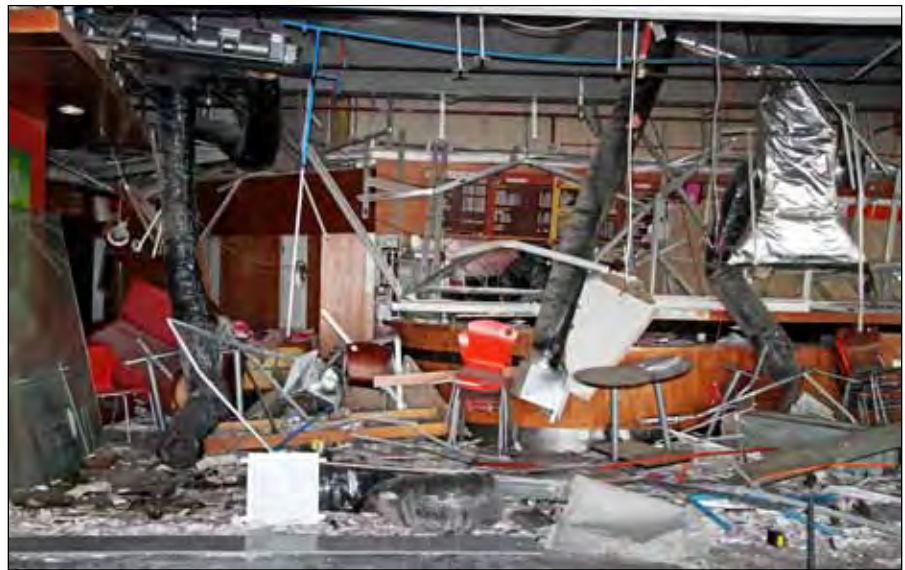
Nonstructural damage resulted in the closure of the international airports in Santiago (see Figure 20) and Concepción, which together handle more than two thirds of the air traffic in Chile. The cost of the earthquake to

**Figure 20.** Nonstructural damage at the Santiago International Airport terminal (photo: E. Miranda).

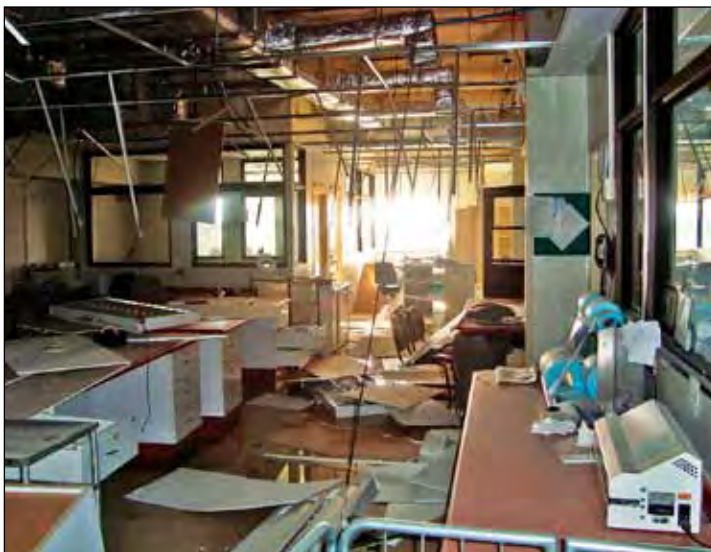
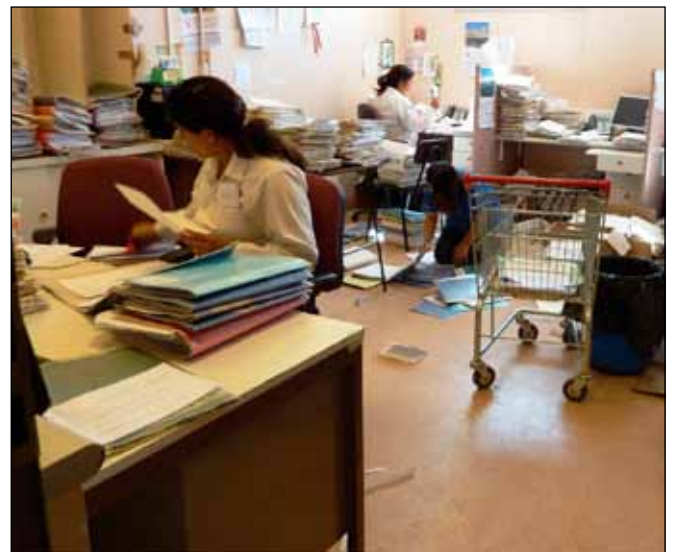
**Figure 21.** (a) Ceiling collapse and nonstructural damage in Chilean hospital (photo: W. Holmes), and (b) tedious reorganization of medical records three weeks after the earthquake (photo: J. Mitrani-Reiser).

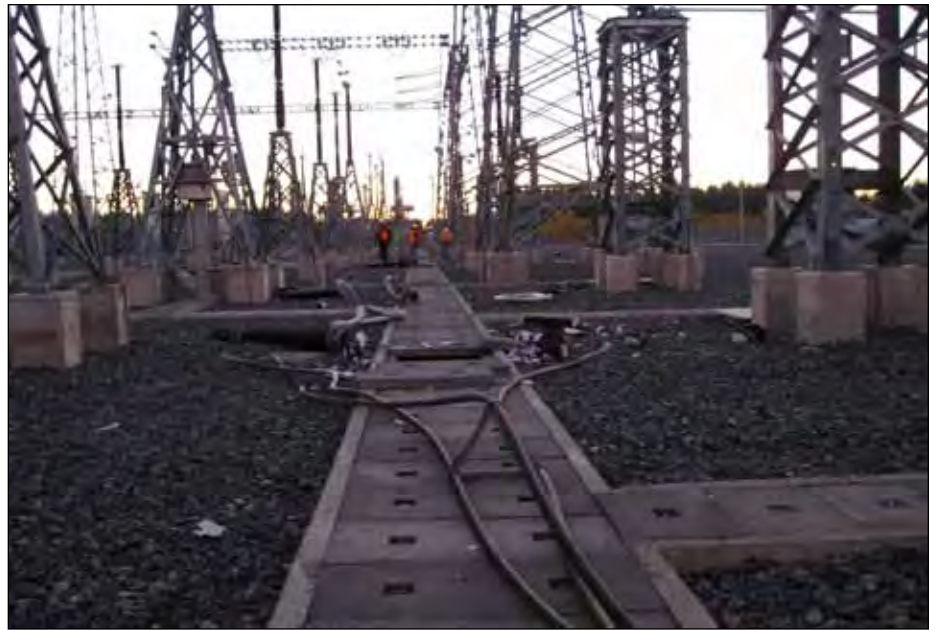
live-tank circuit breakers, which are used sparingly in the western United States. There were more than 25 failures reported in these elements, but that represented only a small percentage of the inventory (Figure 22). The backbone 220 kV and 500 kV systems, which were designed with earthquake provisions, performed reasonably well overall. Lower voltage subtransmission systems near the coast, where there were higher levels of ground shaking, were damaged sporadically. The low-voltage distribution system was also affected by collapsed buildings and damaged poles. Two weeks after the earthquake, the distribution system service was restored.

**Figure 22.** Damaged candlestick style live-tank circuit breakers (photo: TCLEE).

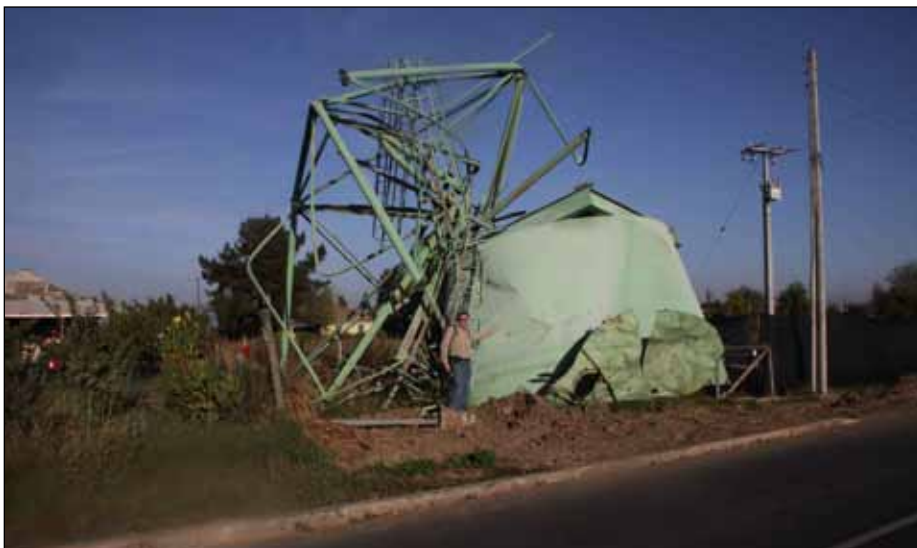
**Figure 23.** Typical collapsed elevated small steel tank (constructed in 1999) (photo: TCLEE).

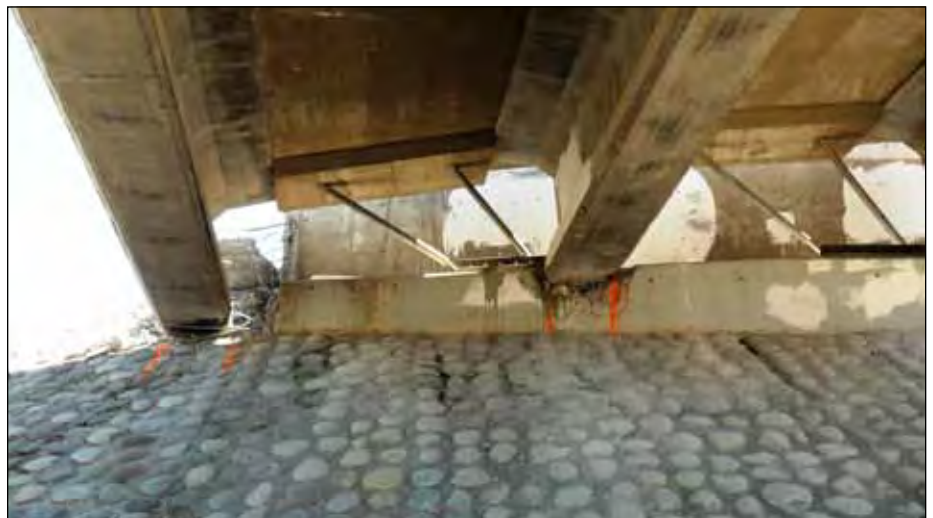
Despite higher-than-anticipated spectral accelerations, column damage was slight, perhaps because the lack of transverse restraint and insufficient support length allowed many superstructures to separate from their substructures, limiting the demand on the columns. Where this did not happen, column damage was more likely to occur, such as the shear failures of several columns under the approach span to

**Figure 24.** Lateral movement of the superstructure of Las Mercedes Bridge across Route 5 near Rancagua, due to absence of end diaphragms and transverse shear keys. Note extreme deformation of vertical seismic bars and damaged curtain walls (photo: Ministerio de Obras Públicas).

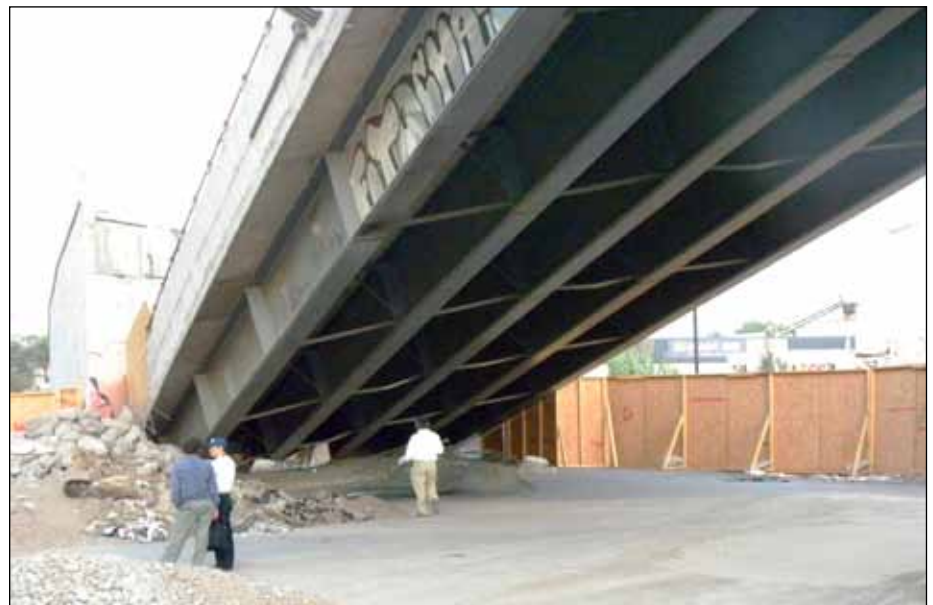
**Figure 25.** Unseating at the abutment of the skewed steel plate girder, Matta-Quilicura Bridge, north of Santiago, due to insufficient support length (photo: J. Arias).

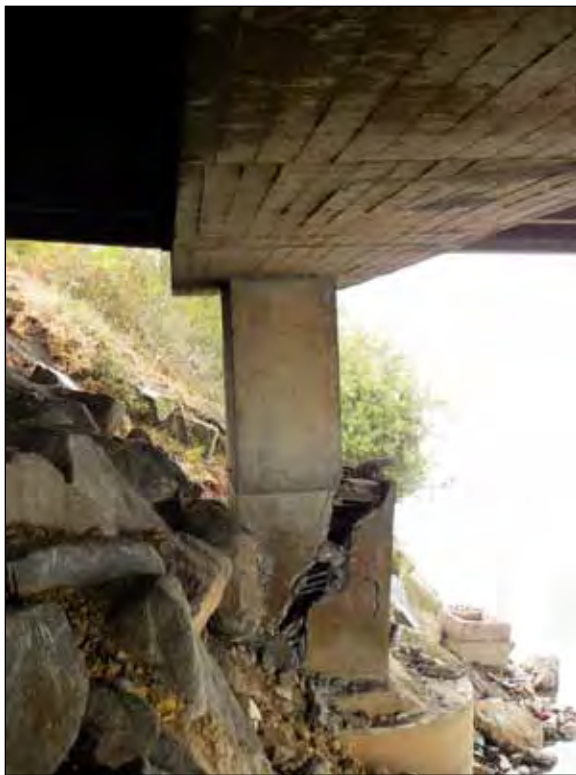
Bridge, built in 1974, was closed due to column shear failure induced by lateral spreading at the approach, as well as interior pier settlement in excess of 0.5 m due to liquefaction. (See also Transportation Systems below and Figure 26). At the Bio-Bio Bridge, built in 1937 and closed in 2002 to all but pedestrian traffic,

the Juan Pablo II Bridge across the Bio-Bio River in Concepción, apparently due to imposed displacements from liquefaction-induced lateral spreading (Figure 26). Other bridges across the Bio-Bio River also suffered damage from lateral spreading, as noted above under Geotechnical Effects.

**Figure 26.** Shear failure in a column in northern approach to Juan Pablo II Bridge across Bio-Bio River, Concepción, due to lateral spreading and the propping action of the superstructure at the top of the column (photo: J. Arias).

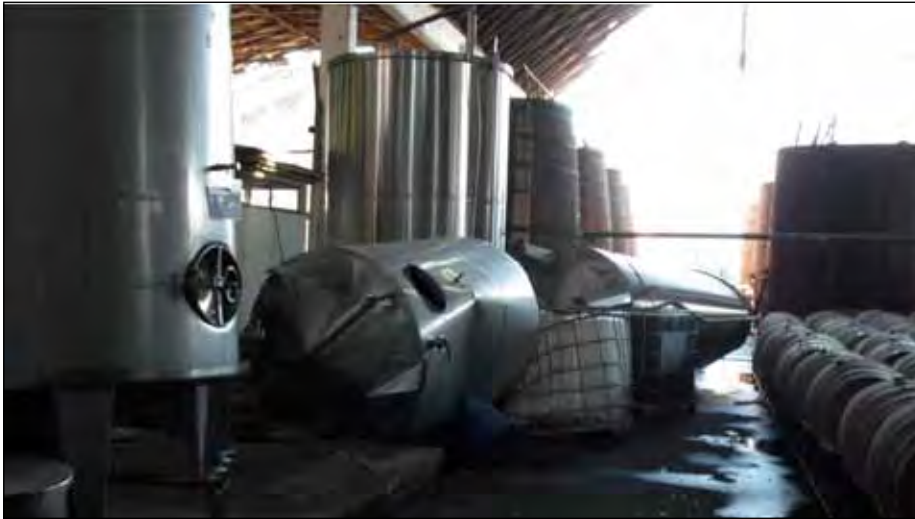
**Figure 28.** Typical damage to storage tanks in wineries (photo: R. Leon).
