DELIVERING Success

News You Can Use

Terracon

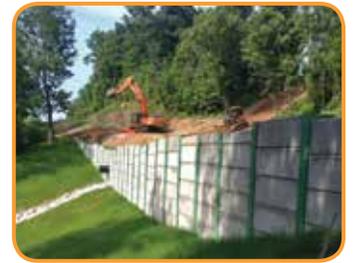
Terrain-based geohazards along pipelines are ripe for proactive intervention.

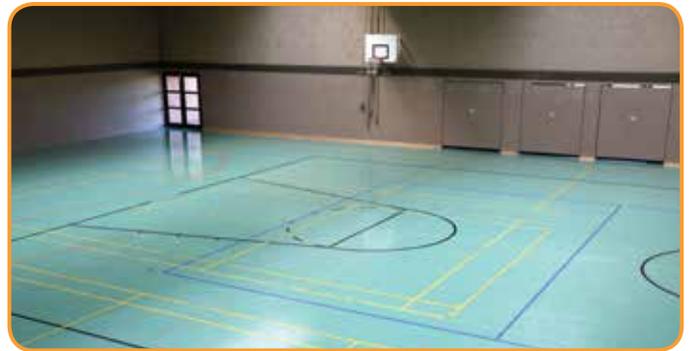
Rubberized, polyurethane gym floors, while resilient, can contain harmful mercury.

The polyurethane floors are typically “poured” in place using two chemical resins that form a durable surface. Mercury was added as the catalyst to allow the two resins to react and solidify. The mercury catalyst is not completely bound in the flooring matrix, meaning some floors can emit mercury vapors that are absorbed and then re-emitted by furnishings and equipment such as floor and wall mats, porous fabrics, and even basketballs. As the floors age and deteriorate, mercury vapor release can increase. Mercury vapor emitted by the floors may be at high enough levels to be considered a health hazard. Unfortunately, the floors may also contain unbound mercury that exceeds the EPA's Resource Conservation and Recovery Act (RCRA) limits and can be classified as hazardous waste. Hazardous waste must be removed and disposed of in accordance with federal laws or substantial penalties can be levied against the building owner.

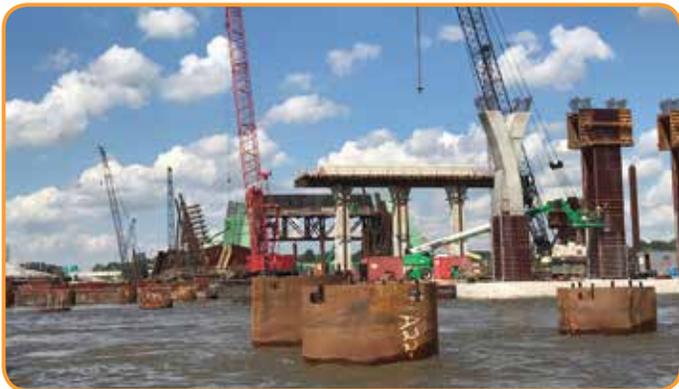
Various stages of construction for the concrete substructures and foundations for the I-74 bridge project, including deep foundations, footings, columns, and pier caps. In the background are the substructures for the new bridge arches.

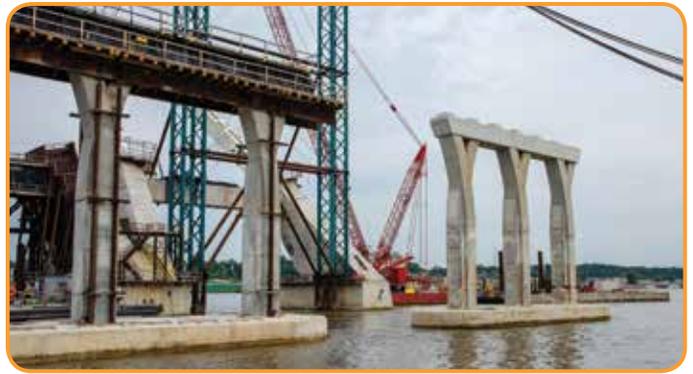
Temperature sensors are connected to the yellow remote radios (tied to the scaffolding in the upper left of the photo) that sends readings to the team.

project. Thermal control of the concrete in these large structures is key to prevent thermal cracking during construction. Temperature sensors with leads as short as 4 feet and as long as 100 feet are installed in all footings, columns, arches, and crossbeams (above and below the water) to record the temperature of the concrete 24 hours a day, 365 days per year. The readings are then monitored by the Terracon team, which check the temperatures remotely every four hours to verify they are within the project specifications. Concrete temperatures cannot exceed 160°F, and the differential temperatures between the core and outside faces of the structure cannot differ by more than 20 to 50°F depending upon the time after the pour is complete. Once the core temperatures are within 50 degrees of the average air temperature for the previous seven days, monitoring is complete, and the forms can be removed.
