## Learning from Earthquakes

# The $M_w$ 8.8 Chile Earthquake of February 27, 2010

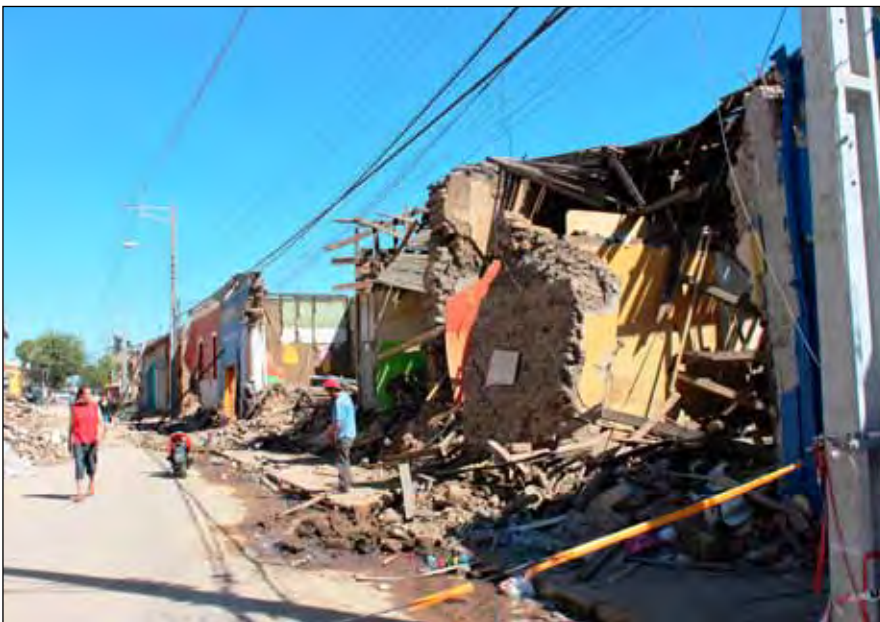
**Figure 13.** Street in Talca (photo: J. Moehle).

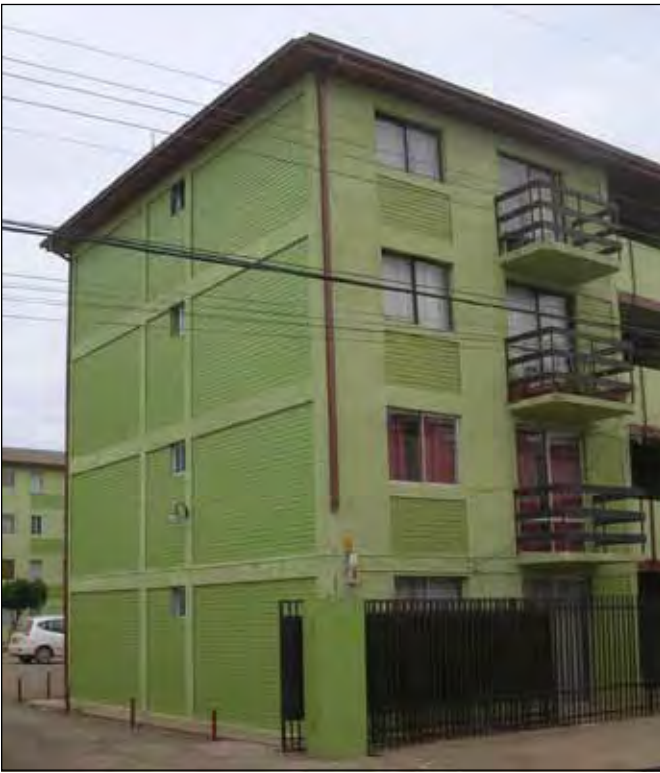
Confined masonry construction is also widely used for buildings one to four stories tall (Figure 14). Exterior walls of clay bricks are first constructed on a concrete foundation and then reinforced concrete confining elements are cast around the brick walls, forming a tight bond between the masonry and concrete elements. These buildings generally performed very well; typical damage (where observed) included diagonal cracking of masonry walls and

wall failure due to lack of confining elements around openings or poor quality of the confinements.

**Figure 14.** Engineered confined masonry apartment building, showing confining elements at boundaries of walls and openings (photo: M. Astroza).

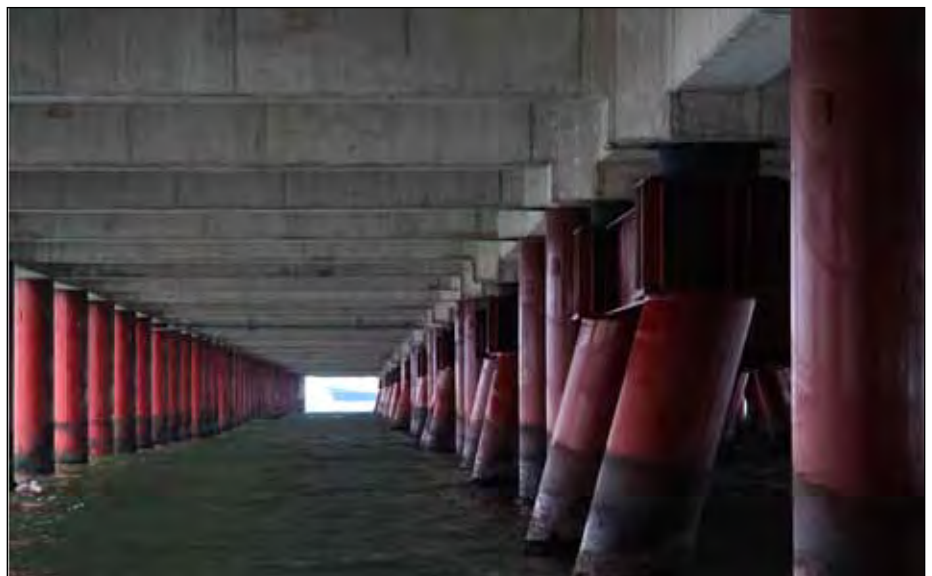
Damage to the major ports of Valparaíso and Concepción (Coronel) has been attributed to strong shaking and liquefaction-induced lateral spreading, rather than the tsunami. The San Antonio Port had been reconstructed between 1992 and 1997, and was undamaged. A new, seismically isolated wharf in Coronel (Figure 27), carrying two container cranes, was not damaged, whereas a neighboring conventional wharf of similar size had weld failures in some steel pile bents.

**Figure 27.** Base-isolated wharf at Coronel (photo: E. Miranda).
